BUREAU OF SHIPS
TECHNICAL INSPECTION REPORT.

OPERATION CROSSROADS.
U.S.S. FALLON (APA 81).

TEST BAKER.

VOLUME 2 [U].

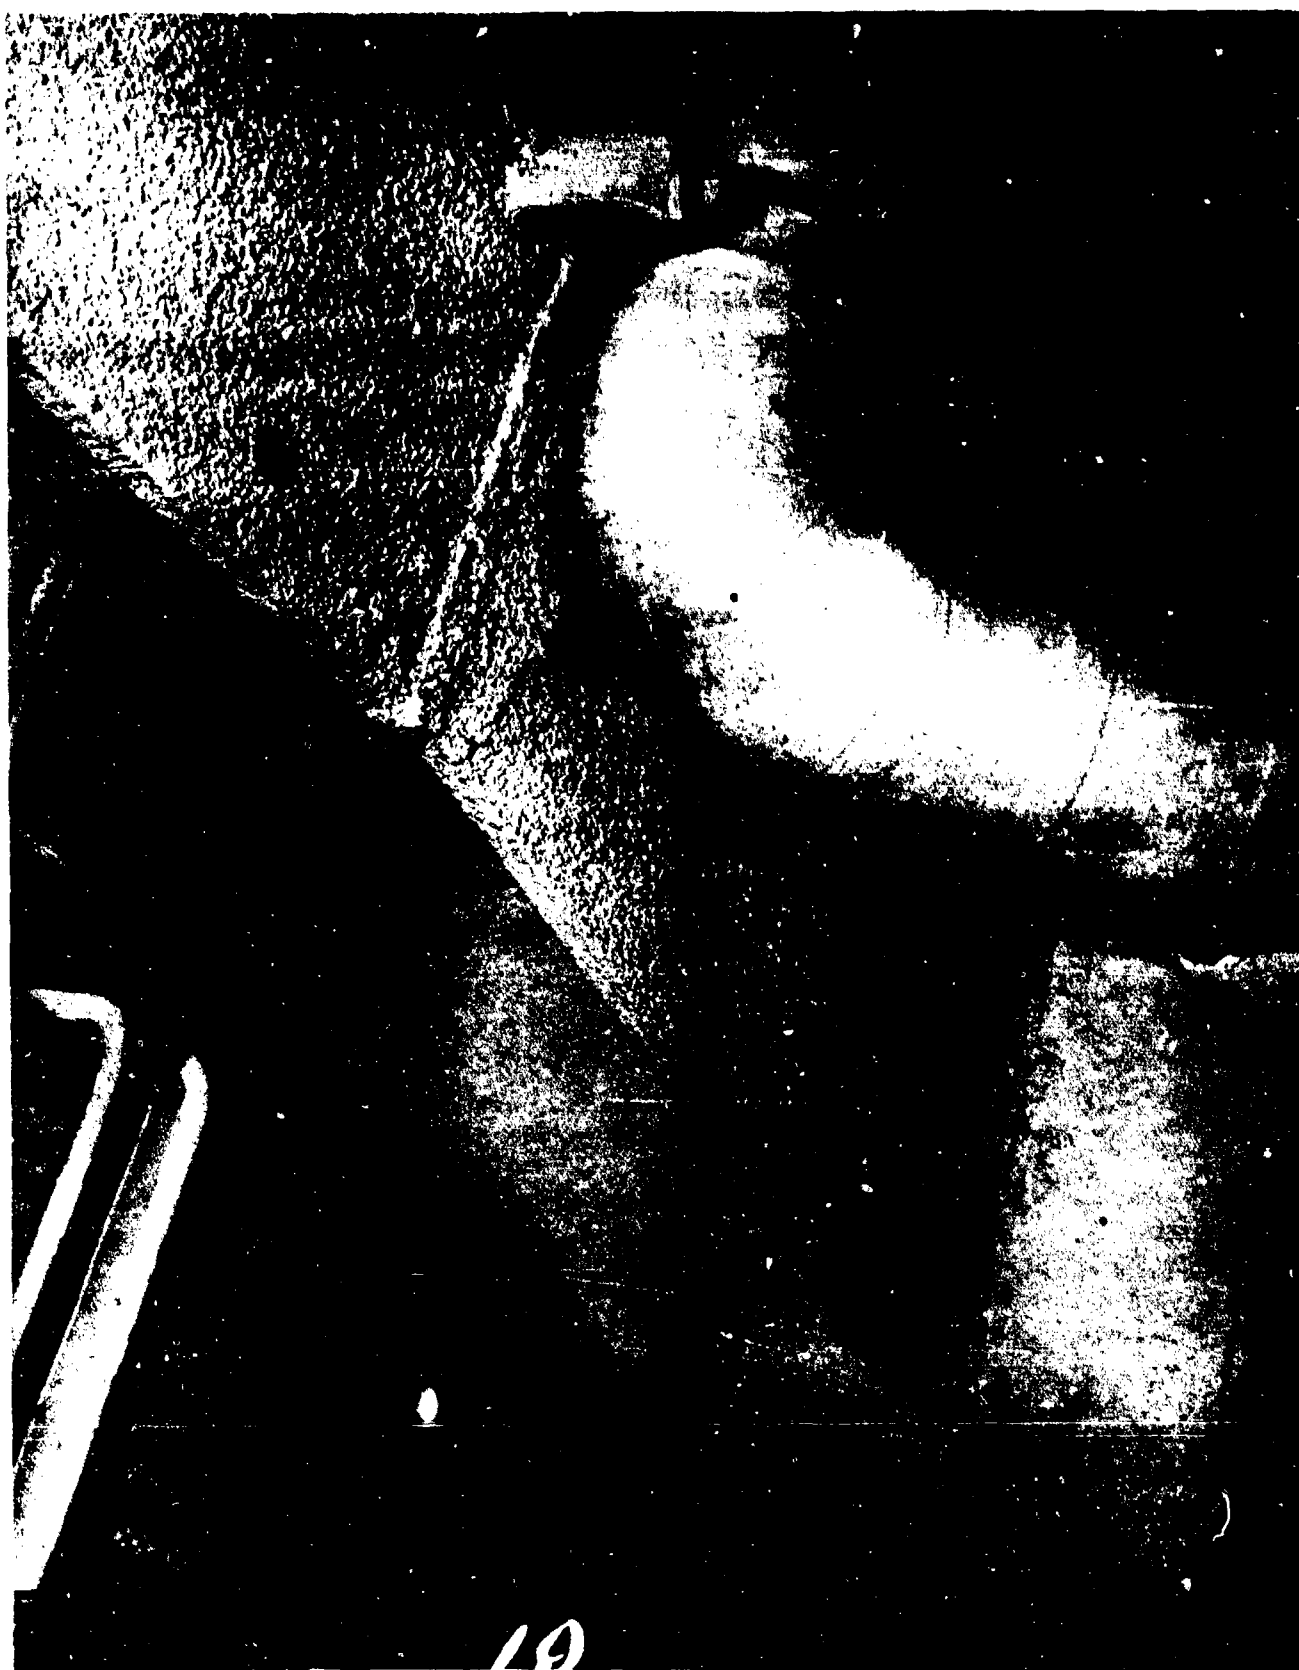
AB-CR-76-2083-10. C-101-L. Troop berthing stress lines in paint at connection of port upper deck longitudinal to bulkhead 124, looking upward and forward.

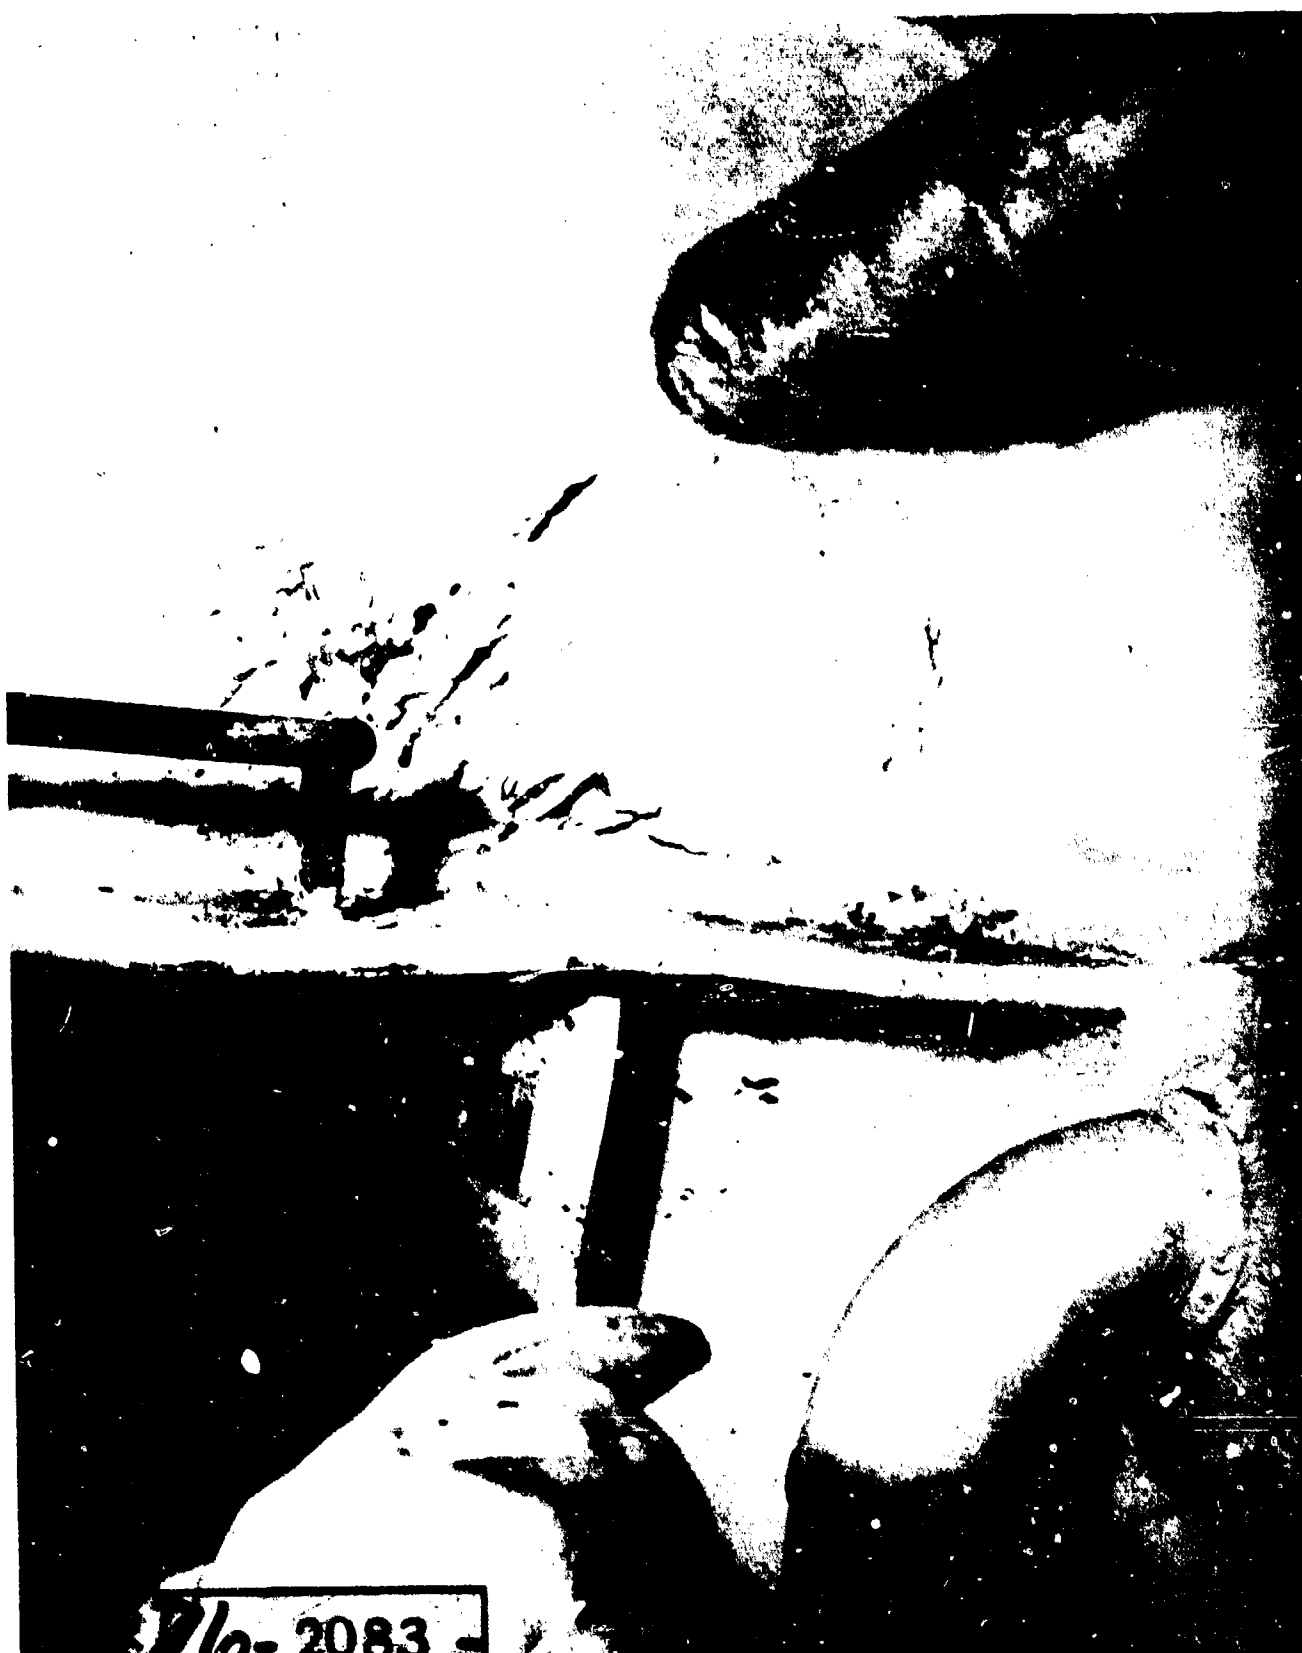
AB-CR-76-2083-7. C-101-L. Troop berthing, looking to starboard at strained connection of port upper deck longitudinal to bulkhead 135. Note lueders lines etched in paint on web at upper left of photo.

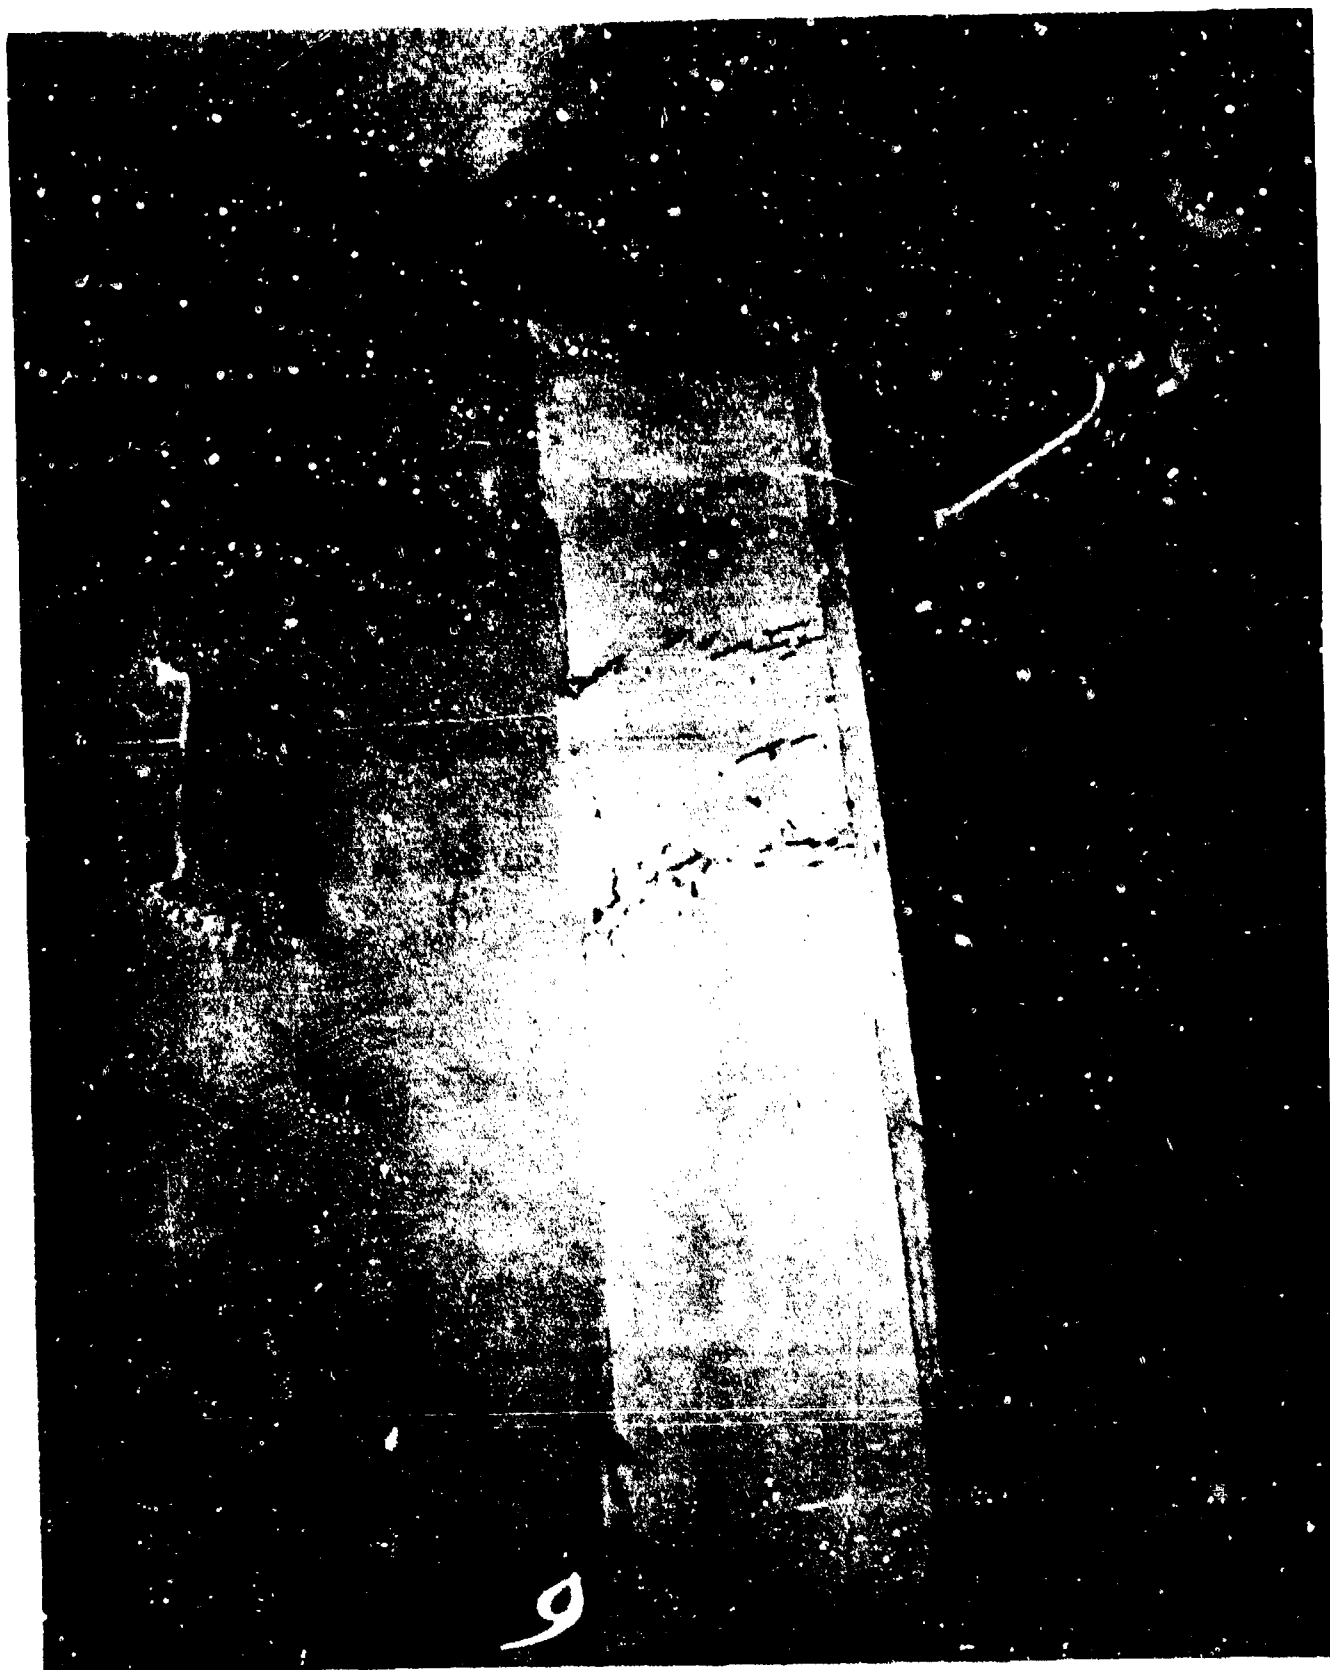
AB-CR-76-2083-9. C-101-L. Troop berthing, wrinkle in bulkhead 135, port side looking aft, upward and to port. Connection at upper center is same showing in 2083-6 and 7. Note stress lines in web of bulkhead

stiffener.
SECRET

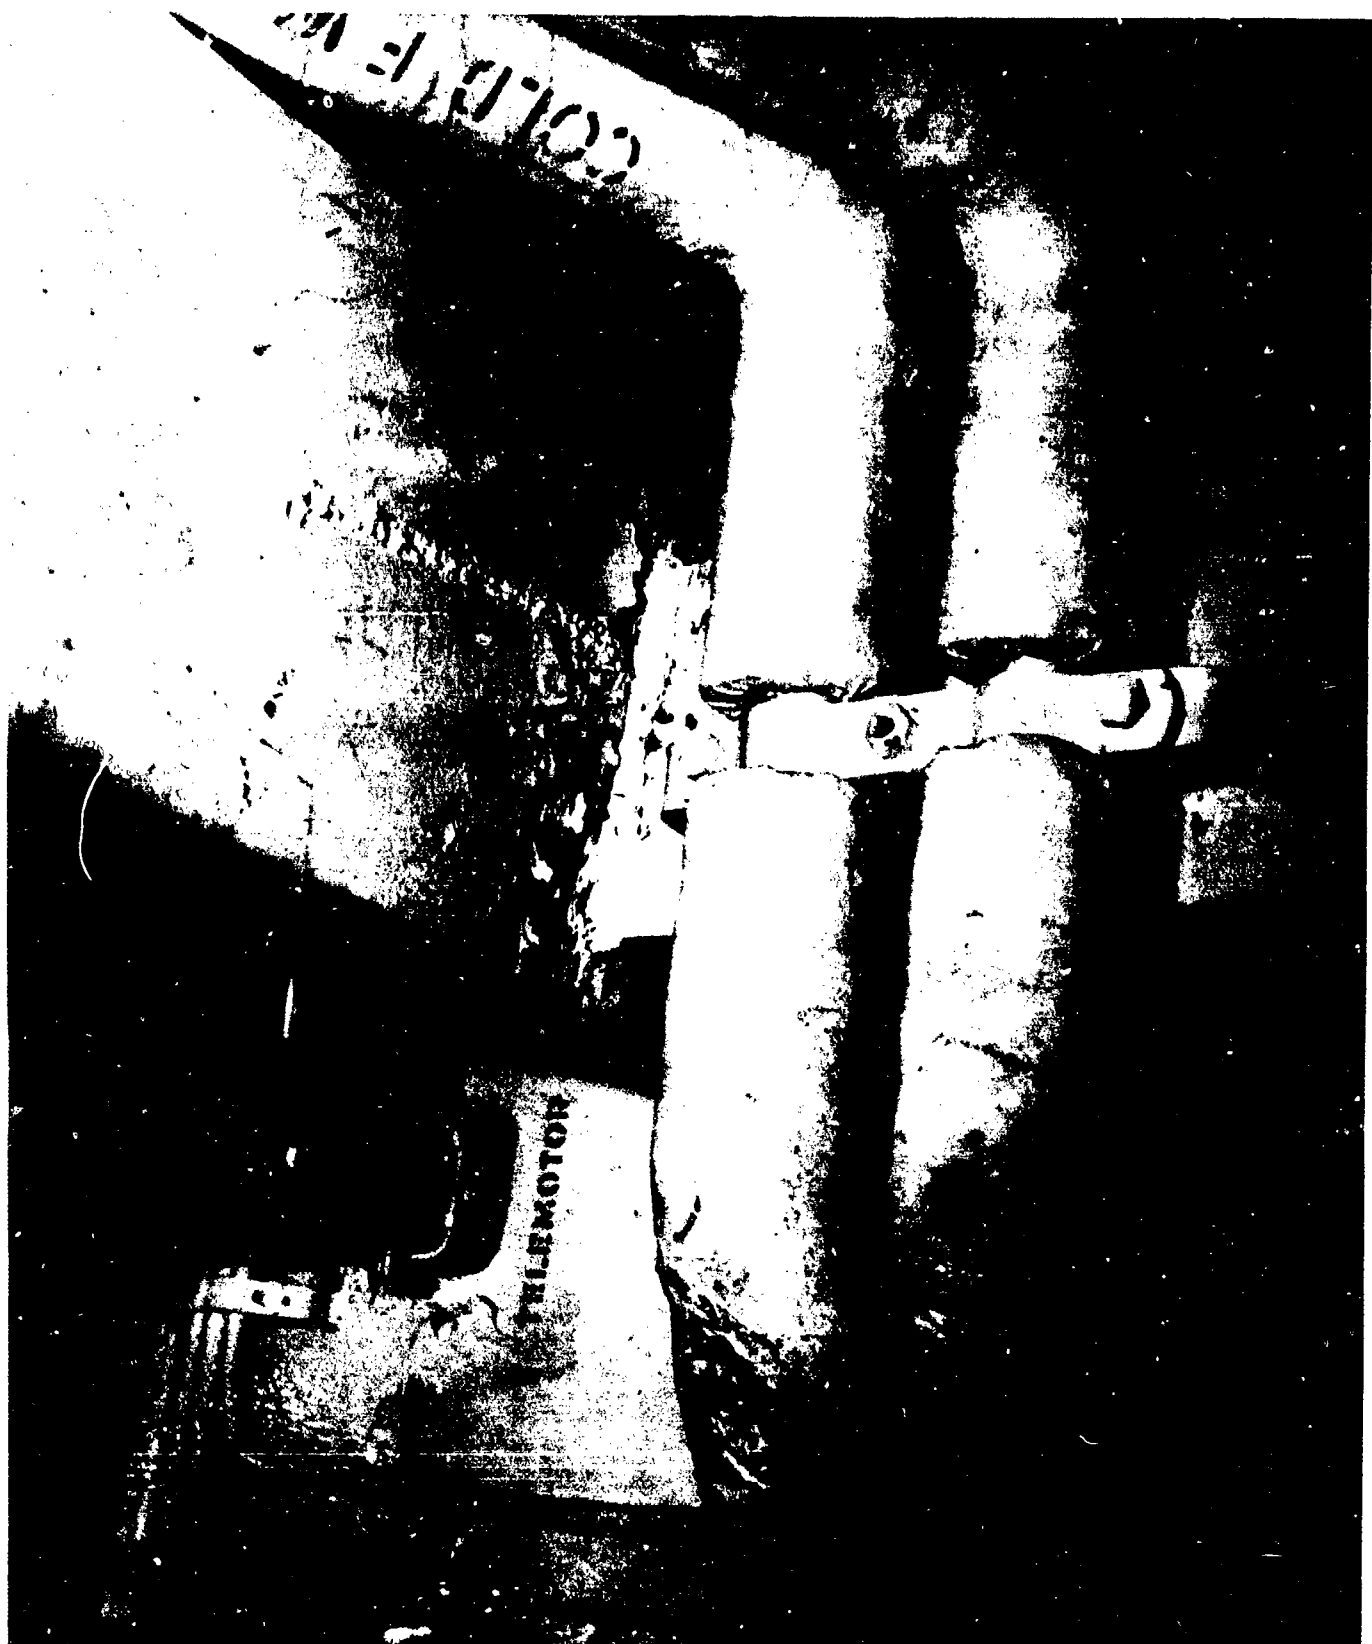
AB-CR-76-2083-12. C-101-L. Troop berthing, strained connection of starboard upper deck longitudinal girder at stiffener on bulkhead 135, looking aft and upward.

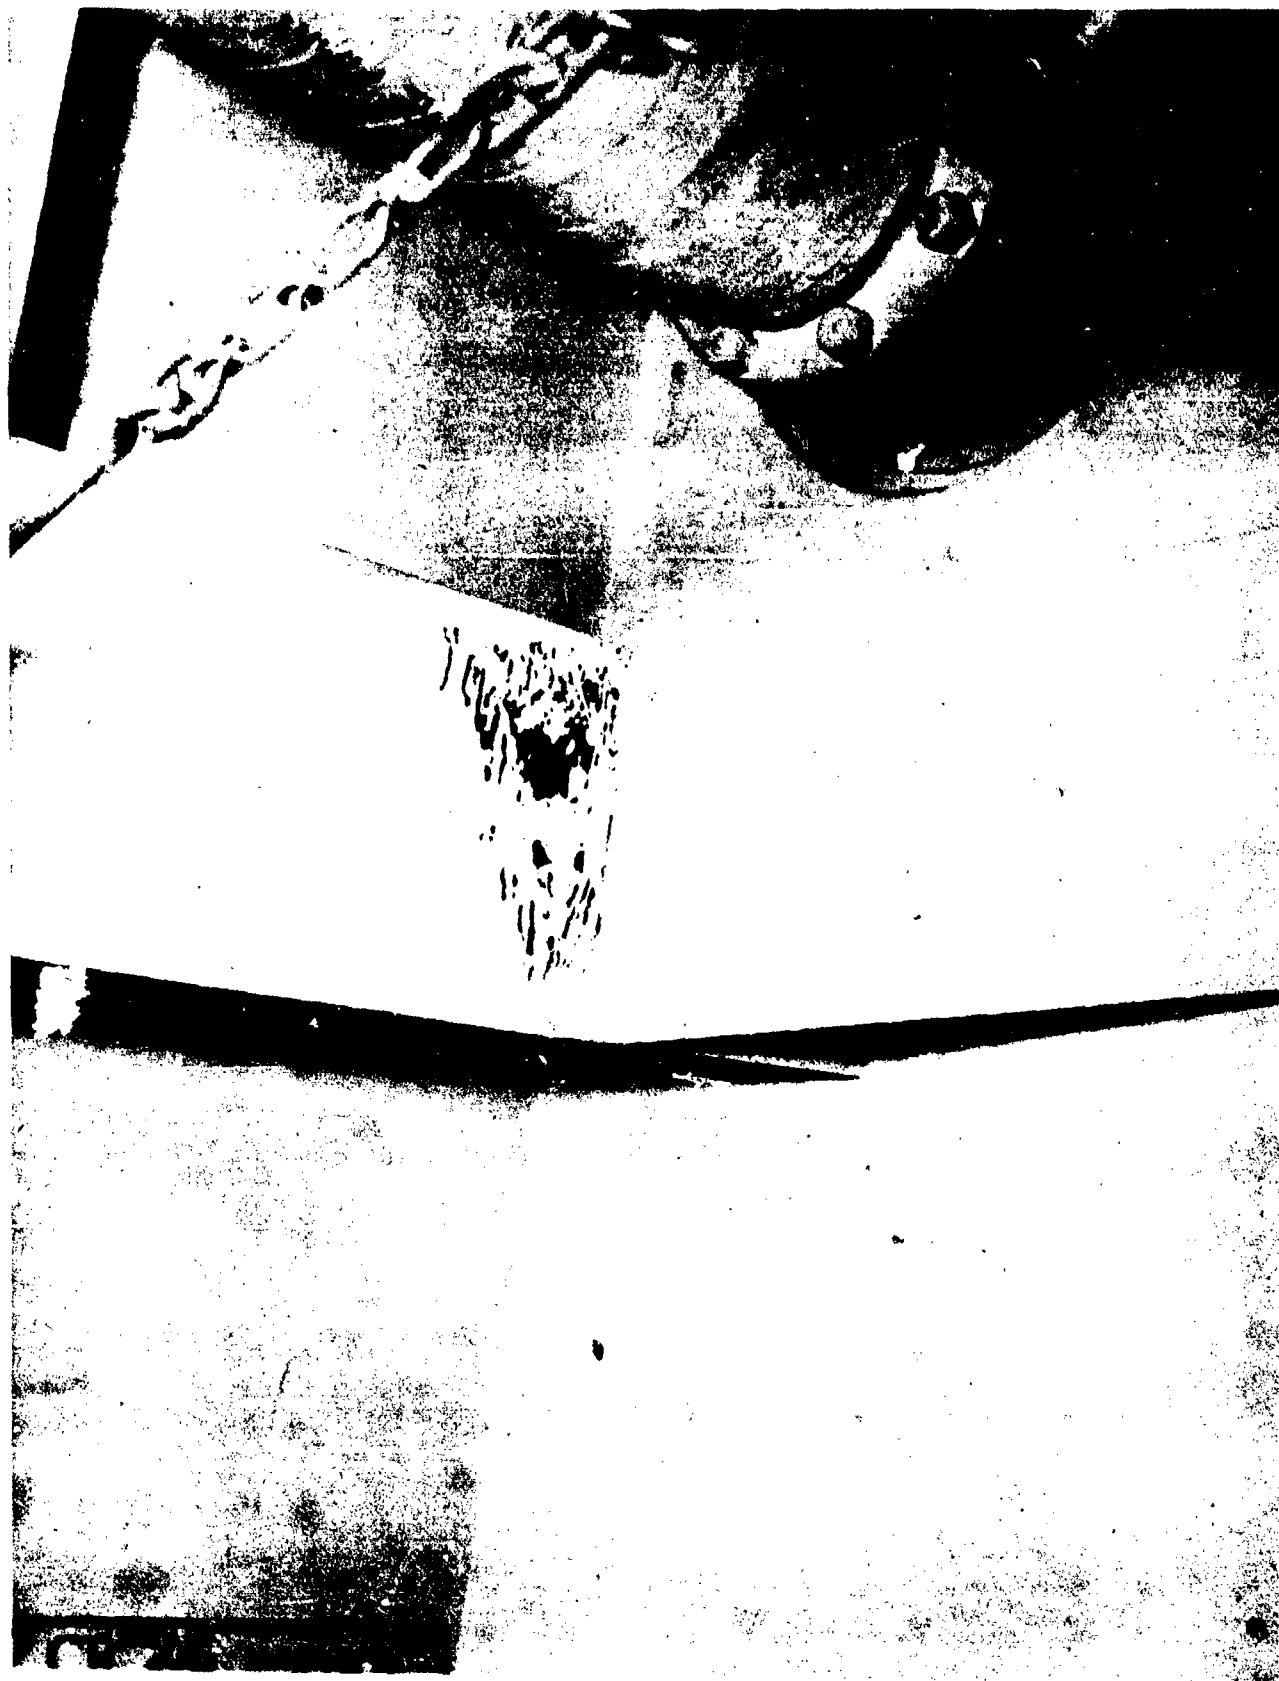
AB-CR-76-2084-11. C-201-L. Troop berthing, looking upward and forward at strained connection of starboard main deck longitudinal to bulkhead 124.

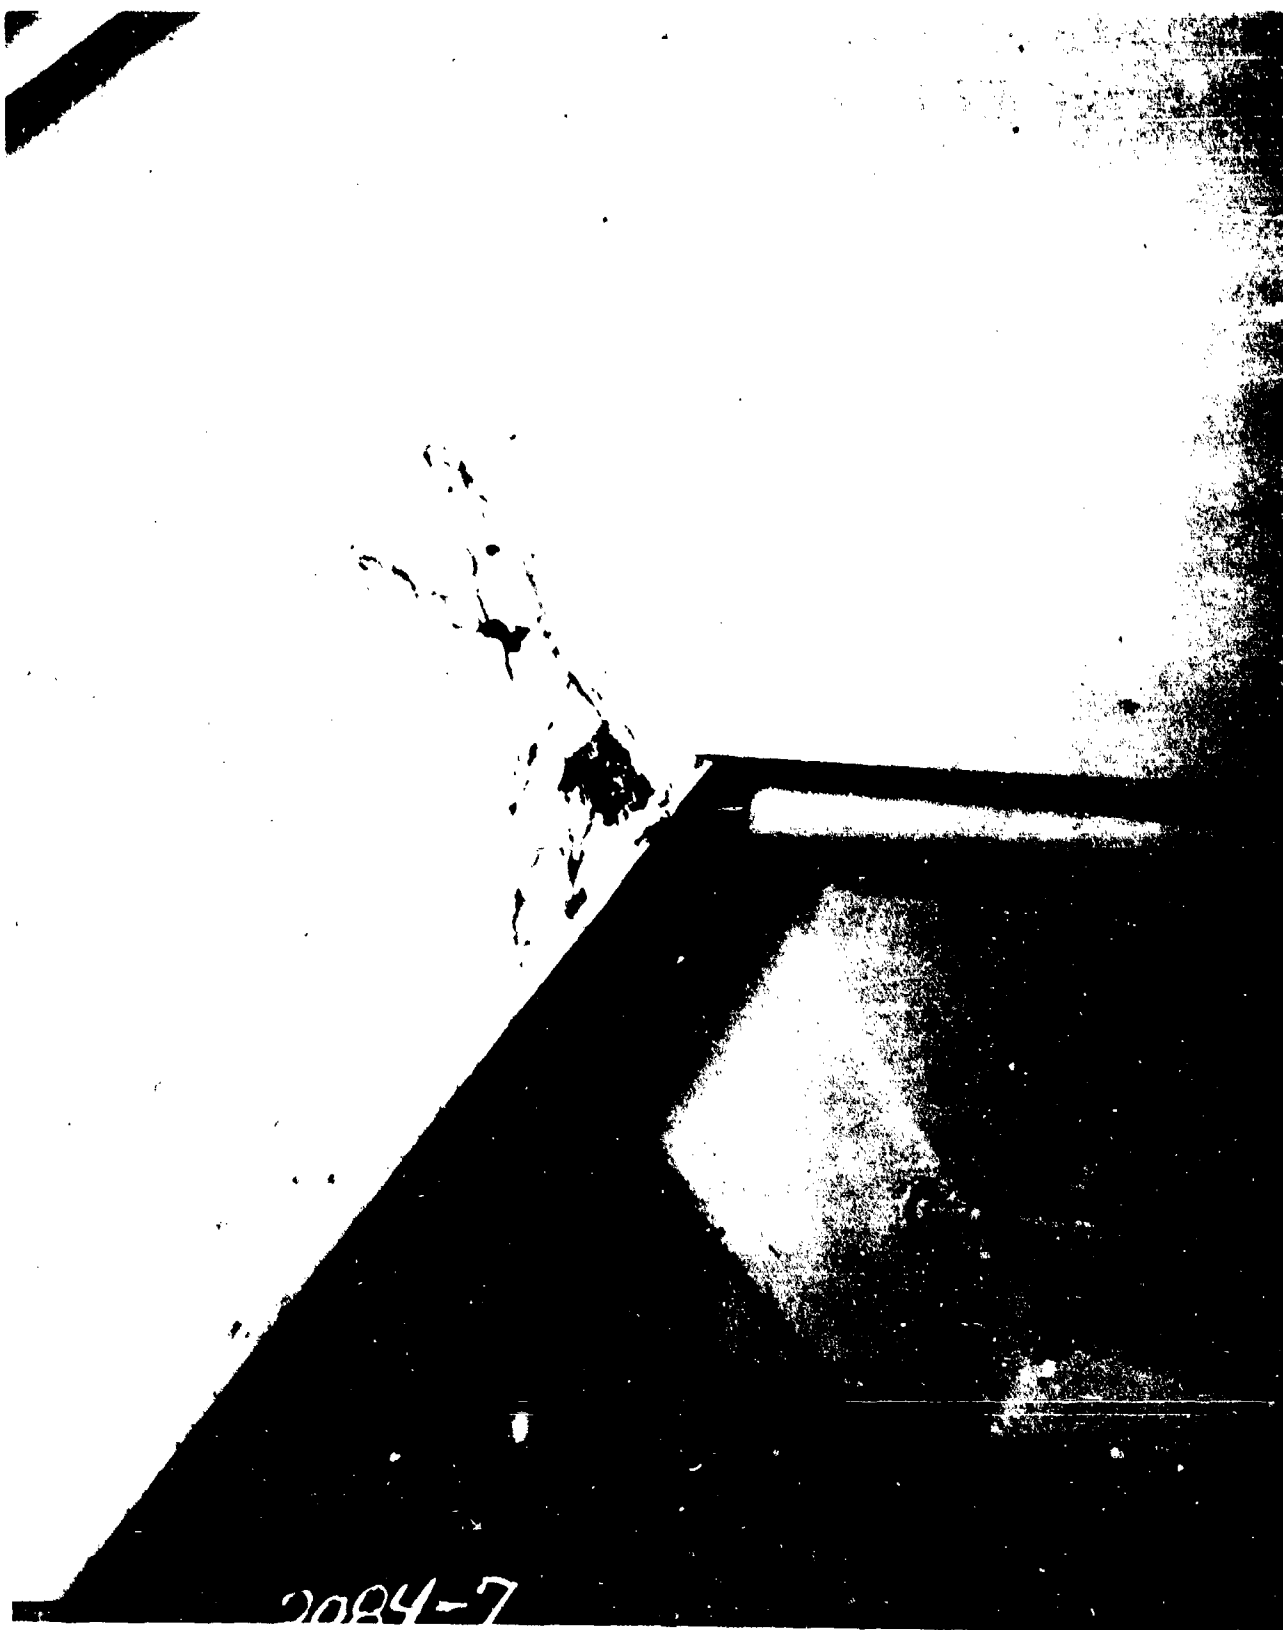
AB-CR-76-2084-7. C-201-L. Troop berthing, looking aft and upward at strained connection of starboard main deck longitudinal girder to bulkhead 135.

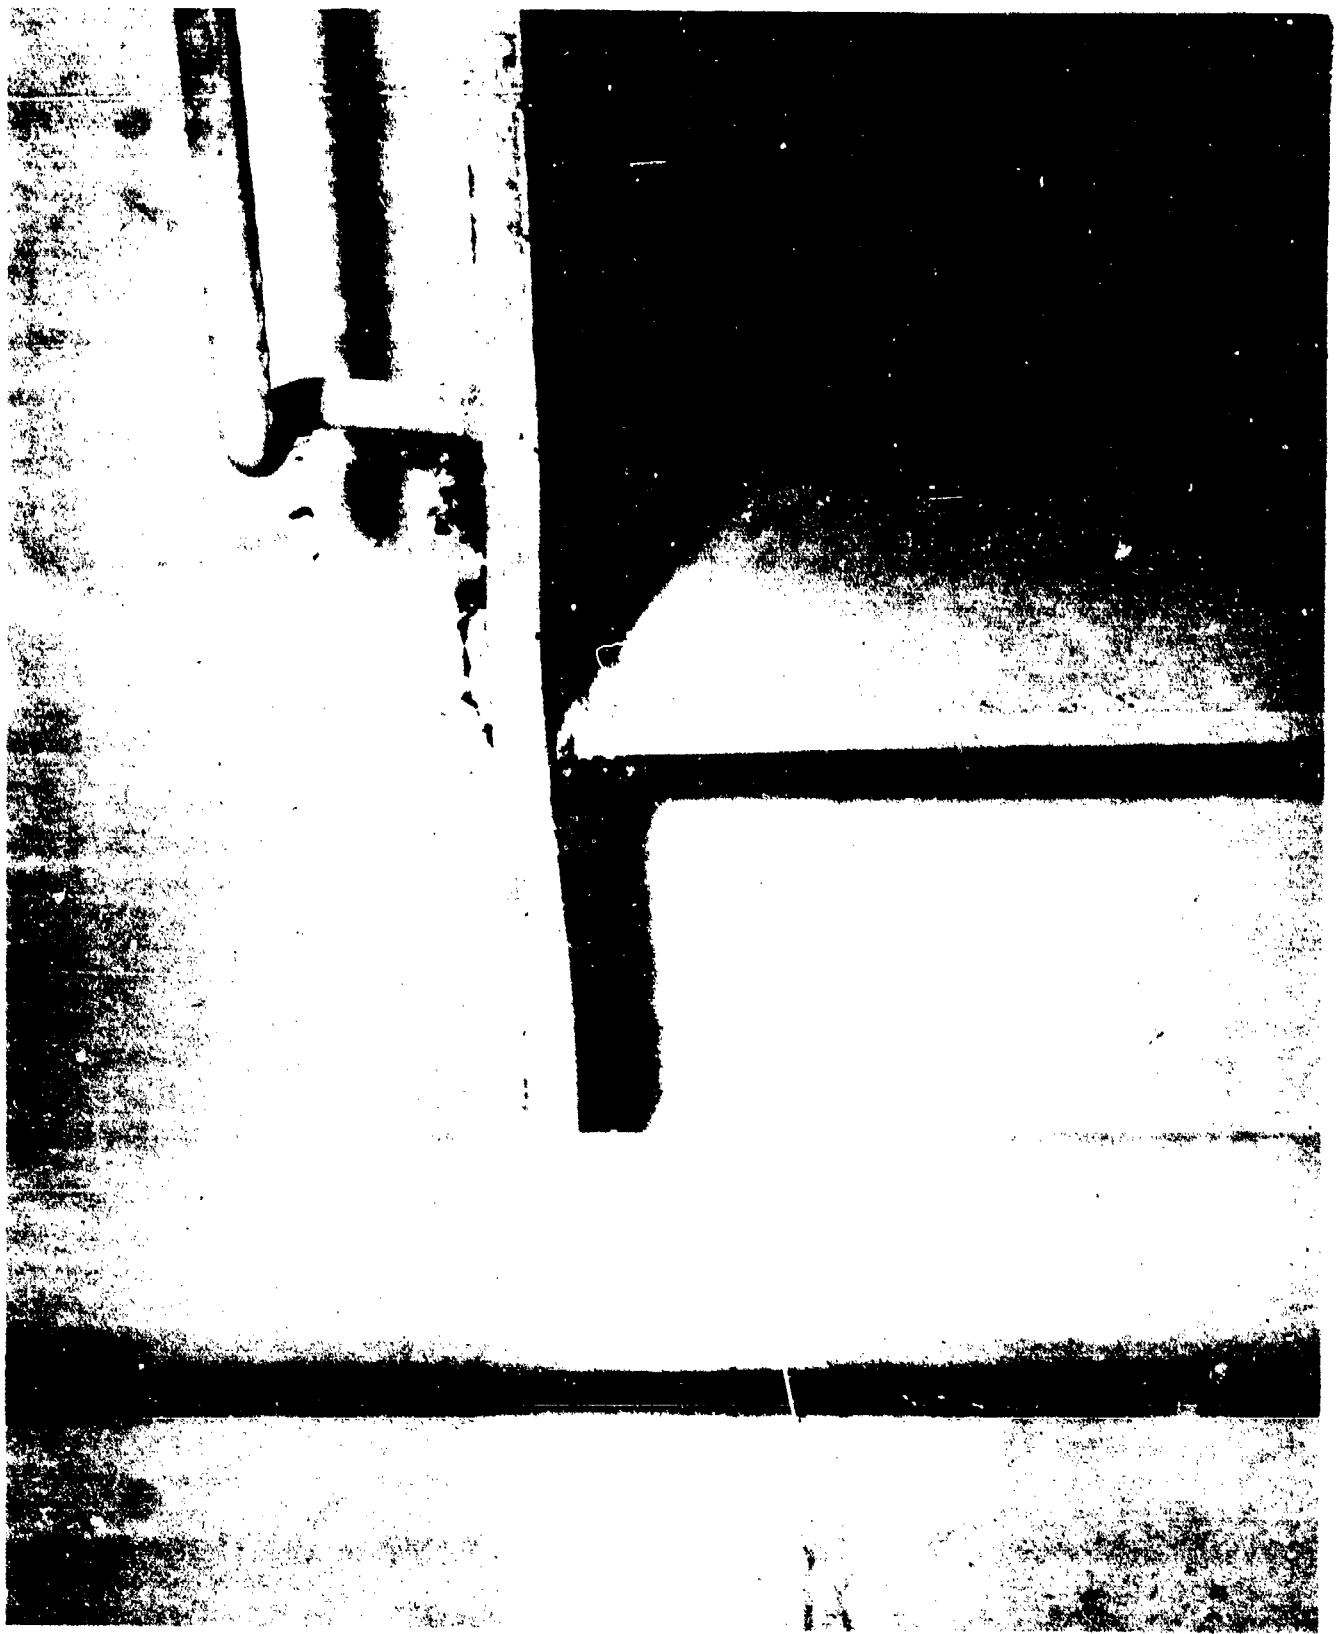
AB-CR-76-2084-8. C-201-L. Troop berthing, looking to port and aft at strained connection of starboard main deck longitudinal girder to bulkhead 135.

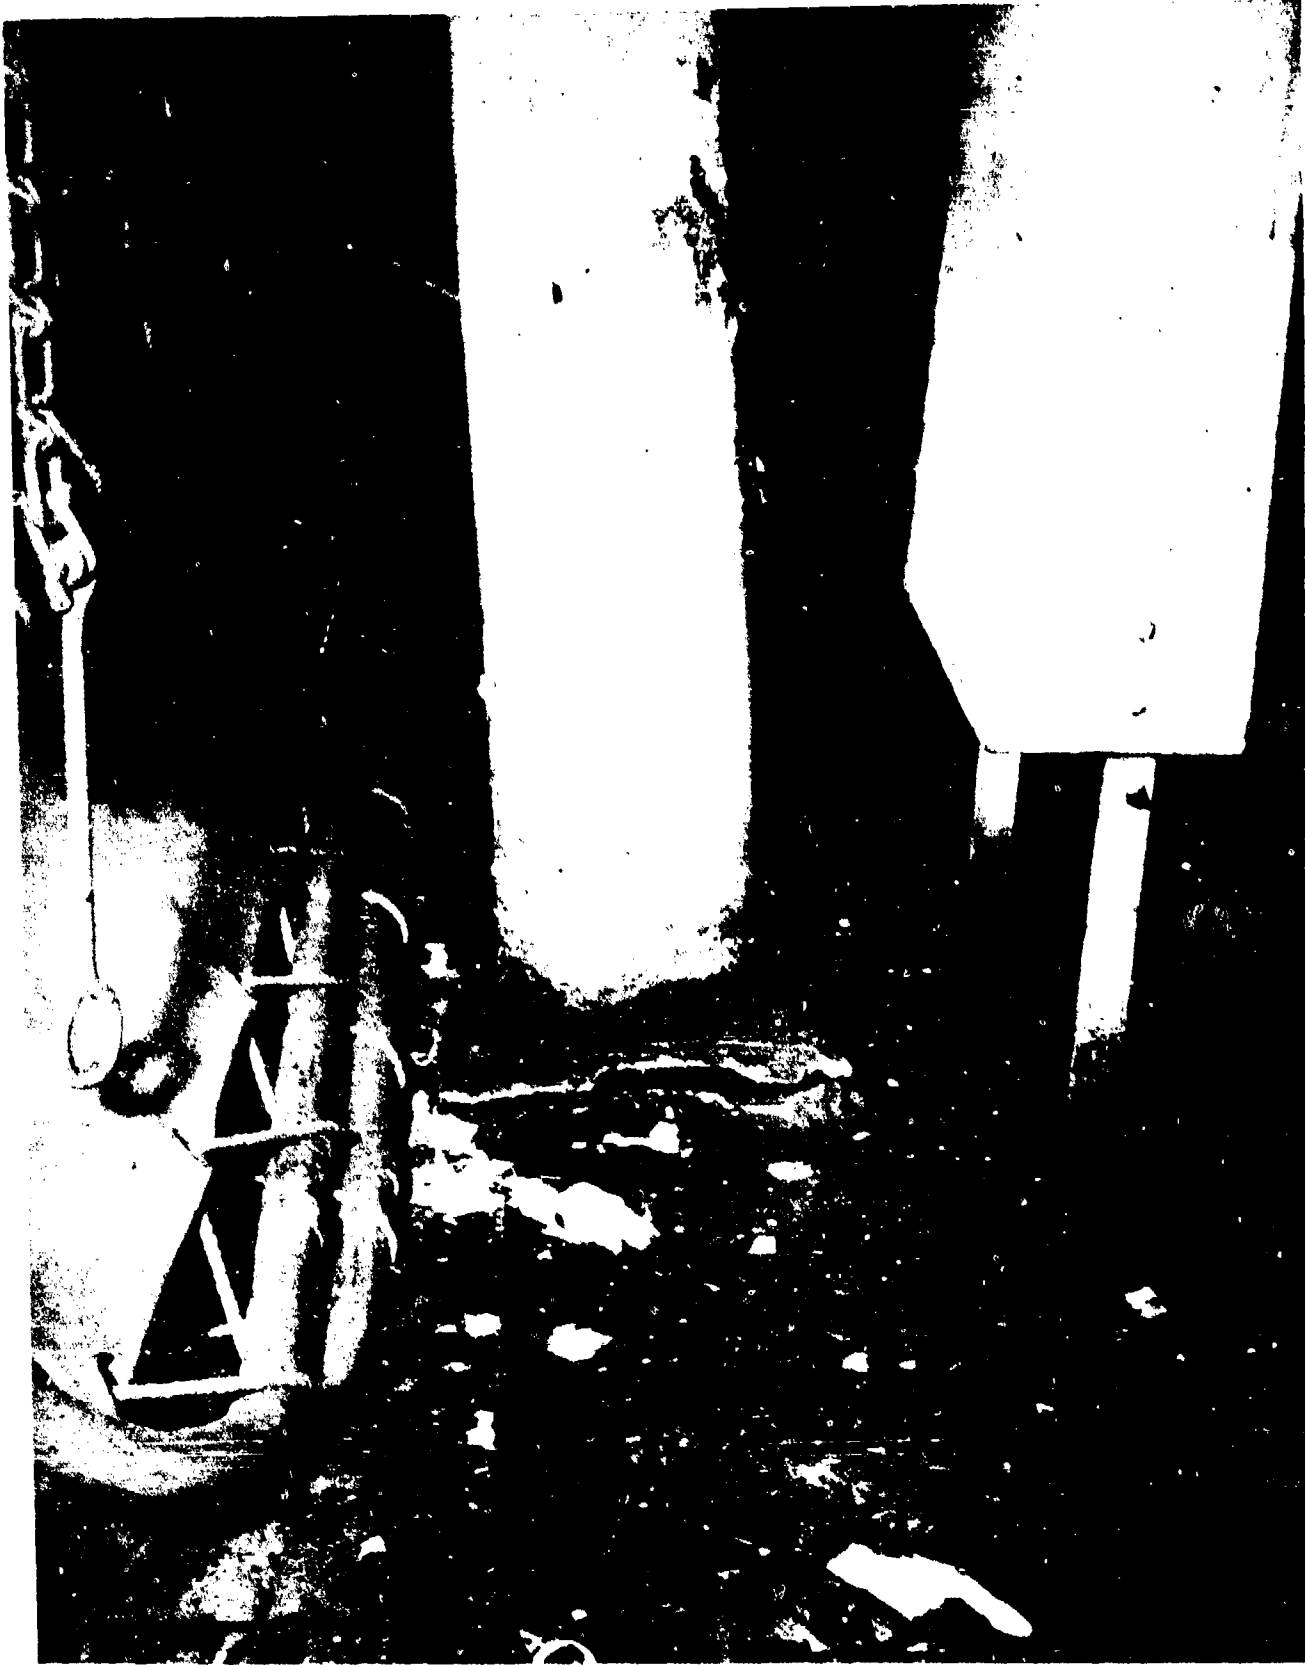
AB-CR-76-2084-9. C-201-L. Troop berthing, stanchion at mid-compartment under starboard longitudinal girder lifted from first platform. (See 2084-10.)

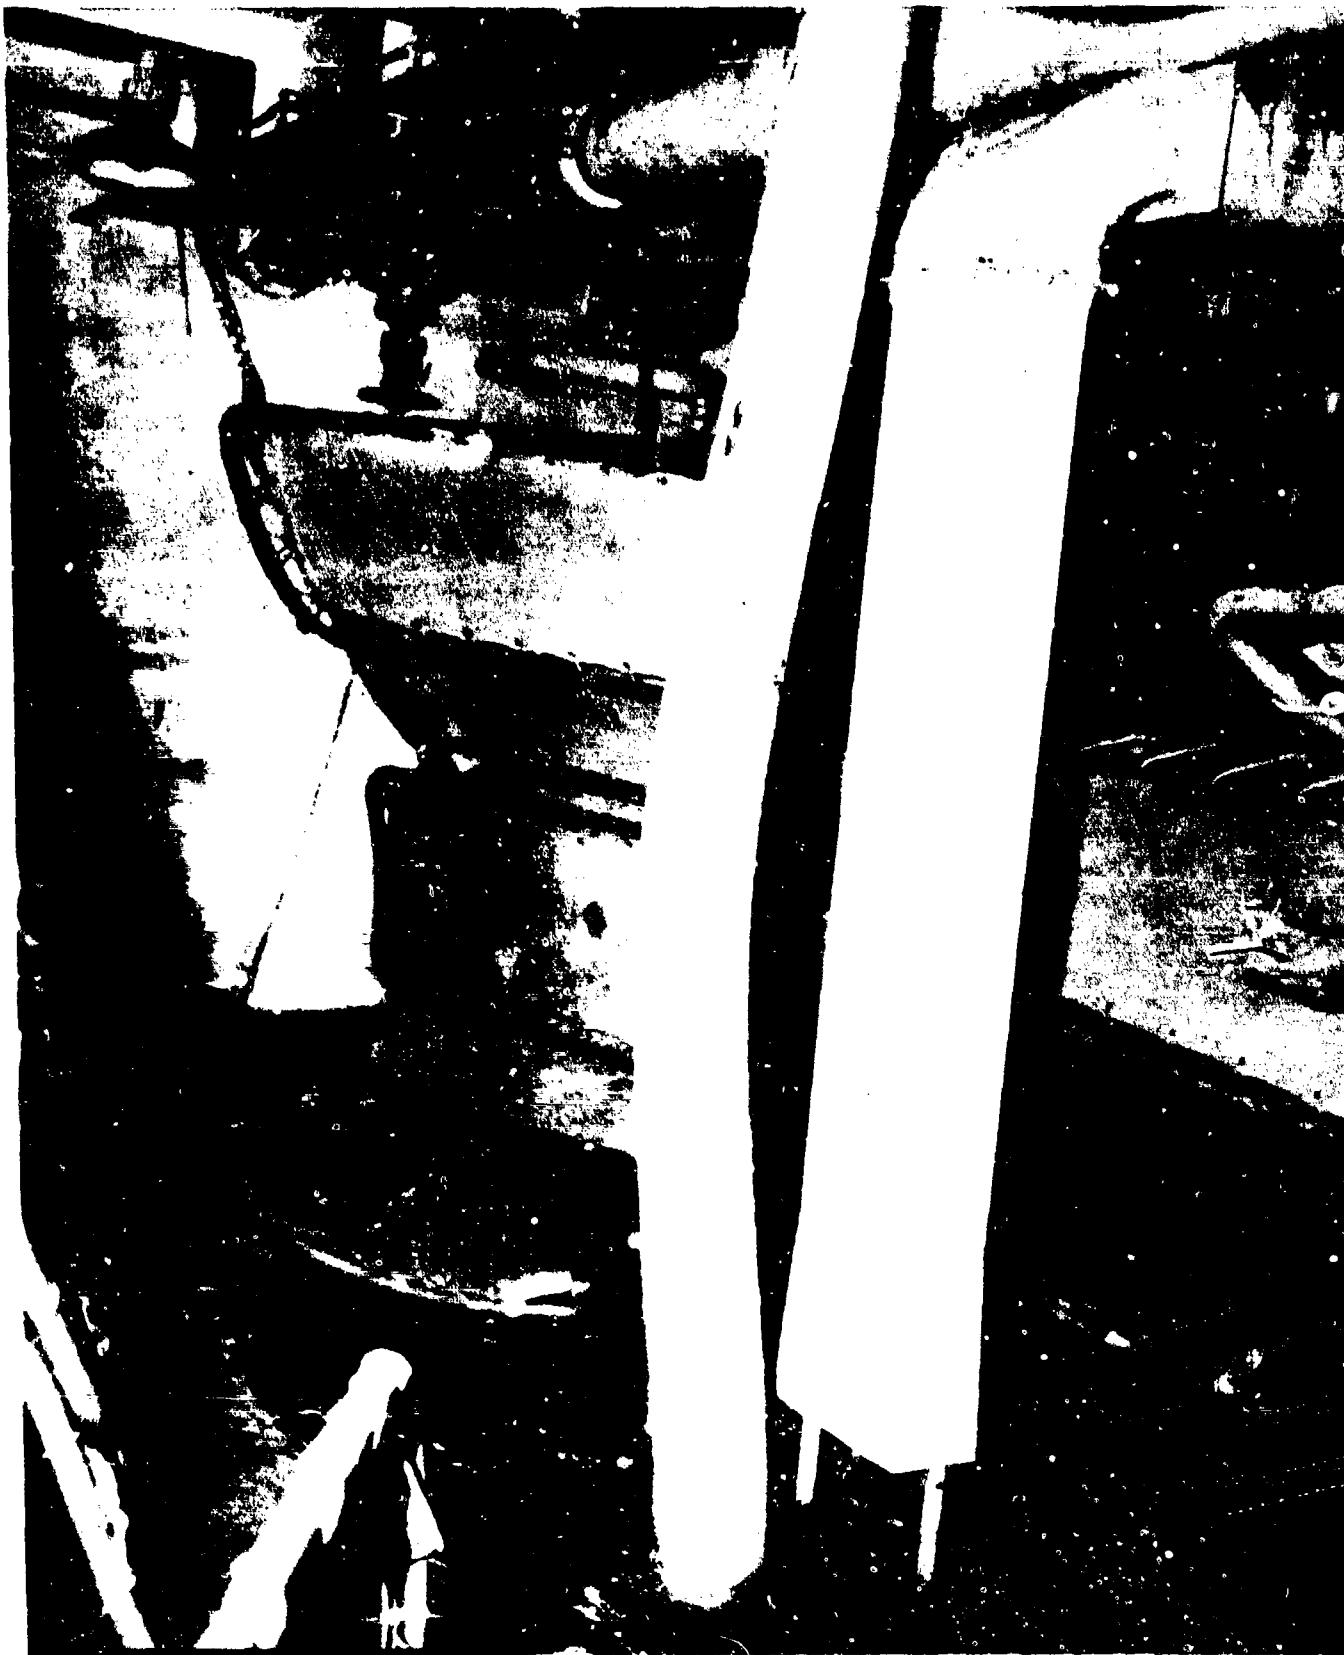
AB-CR-76-2084-10. C-201-L. Troop berthing, buckled stanchions at mid-compartment under starboard longitudinal girder, looking forward and starboard. Note collapsed condition of bunks in this space and stanchion torn loose from deck.

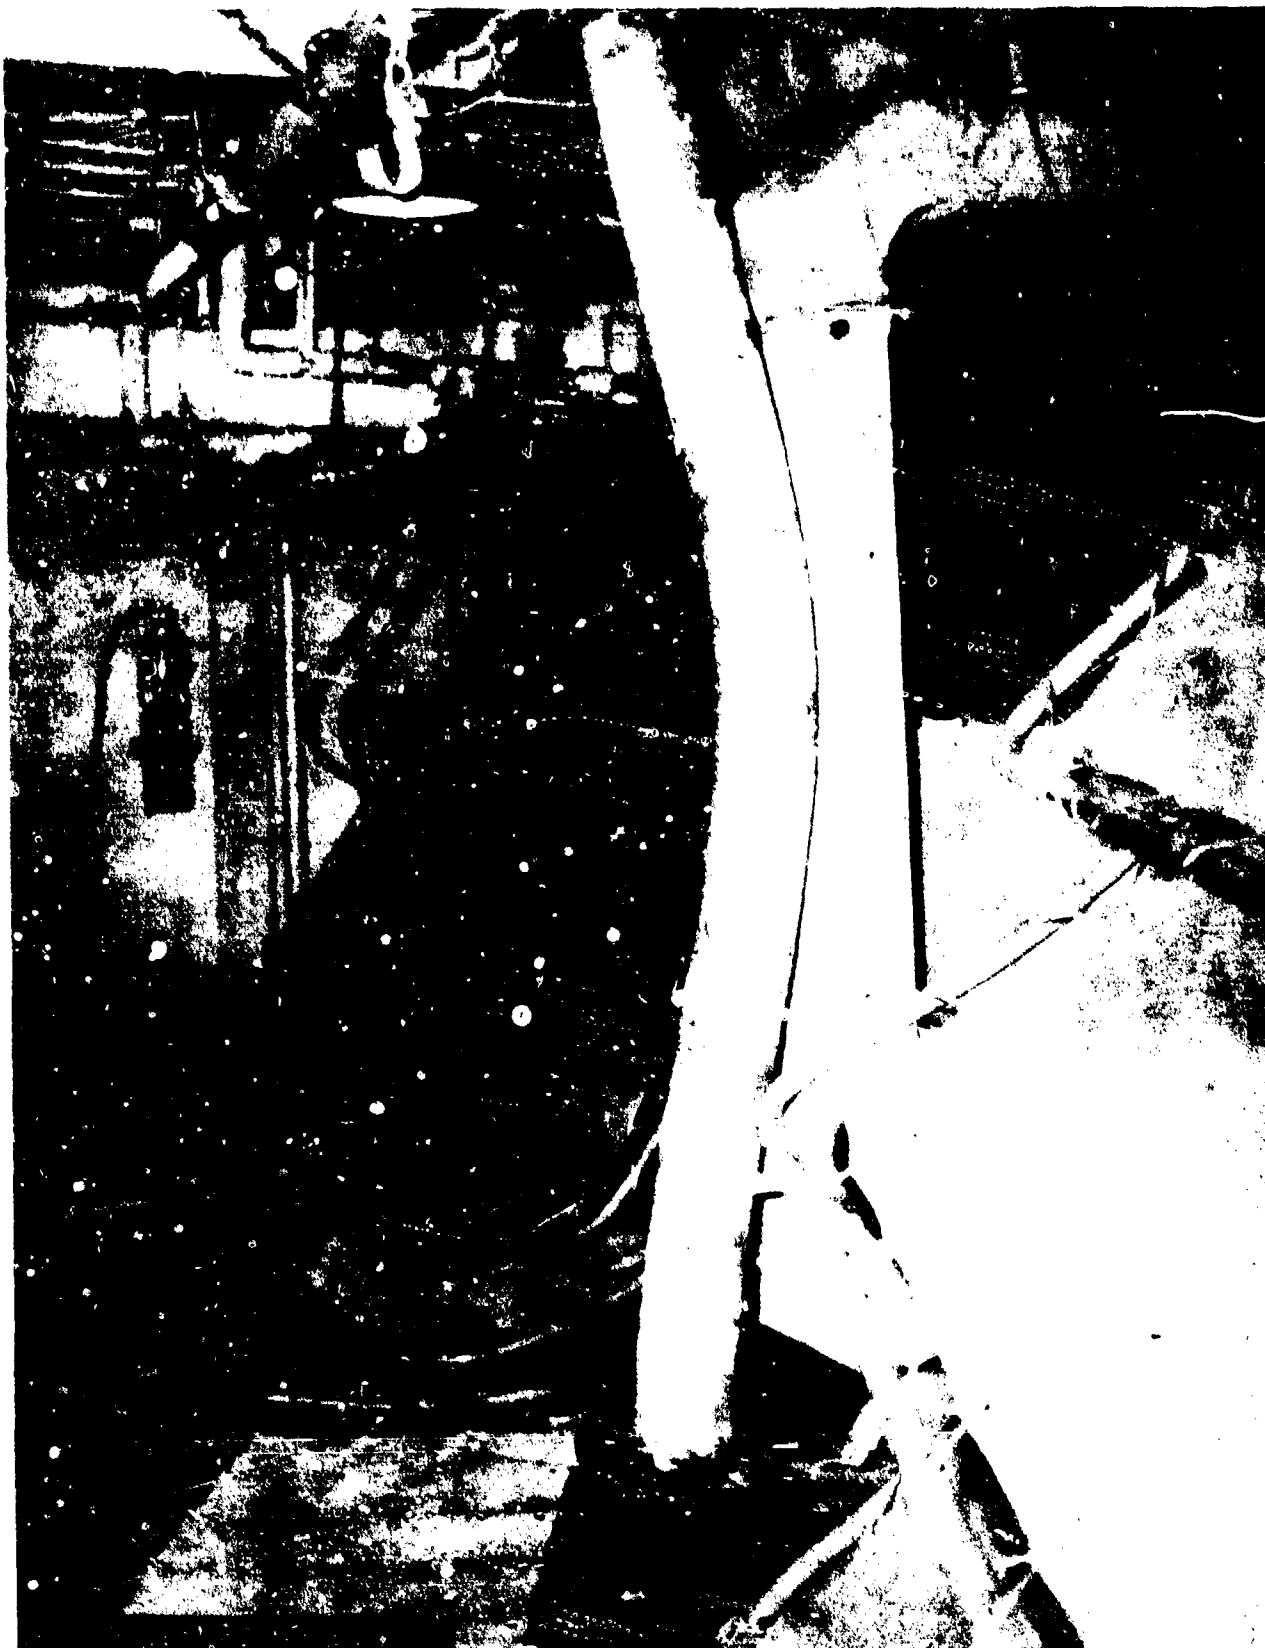
AB-CR-76-2084-12. C-201-L. Troop berthing, buckled stanchion at mid-compartment under port longitudinal girder, looking aft and to port. Stanchion has pulled away from girder.
